Manhole Inspection Summary

Manhole # S01CC2028MH

Insp Date: **7/20/06 7:34 AM**

Location Address: **6506 Cross Country Blvd** Cross Street: **Bancroft Rd**

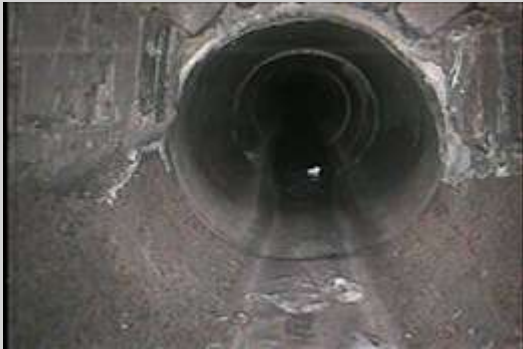
12 in. Circular Gravity Sewer Pipe Out @ 12 O'Clock

Pipe Material: **Clay** ☐ Pipe Lined

Invert Depth: **4.85** (ft.) Flow Characteristics: **Slow**

Infiltration: **Evidence** Pipe Seal Cond: **Sound**

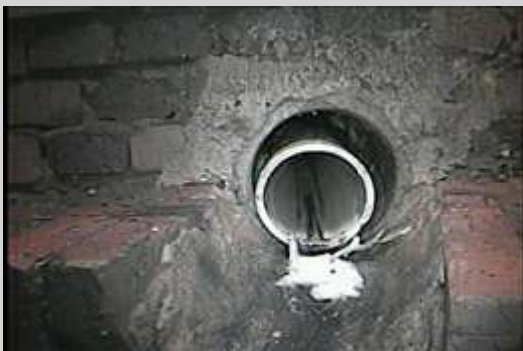
4 in. Circular Gravity Sewer Pipe In @ 3 O'Clock

Pipe Material: **PVC** ☒ Pipe Lined

Invert Depth: **3.95** (ft.) Flow Characteristics: **None**

Infiltration: **None** Pipe Seal Cond: **Unknown**

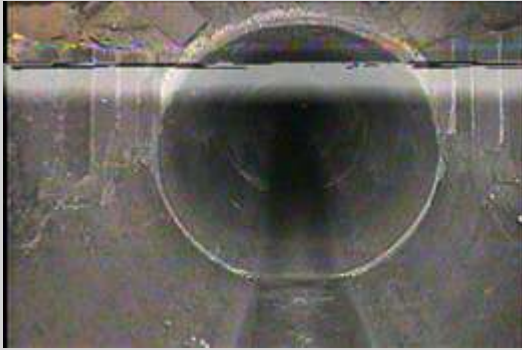
12 in. Circular Gravity Sewer

Pipe Material: **Clay** ☐ Pipe Lined

Invert Depth: **4.80** (ft.) Flow Characteristics: **Slow**

Infiltration: **None** Pipe Seal Cond: **Sound**

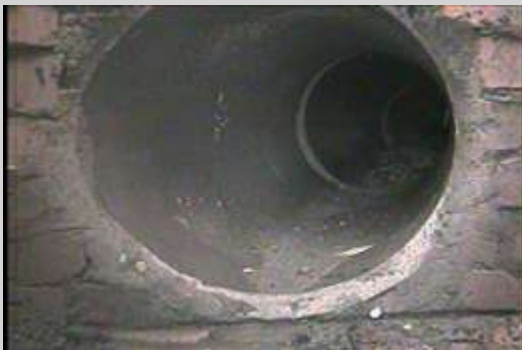
15 in. Circular Gravity Sewer

Comments **9 o'clock is possible overflow connection to sewer**

possible overflow pipe

Invert Depth: **3.56** (ft.) Flow Characteristics: **None**
